# **Report #296**

**Red River Coal Company  
Benthic Macroinvertebrate Survey  
Fall 2014 SFP-2**

**24OCT14**

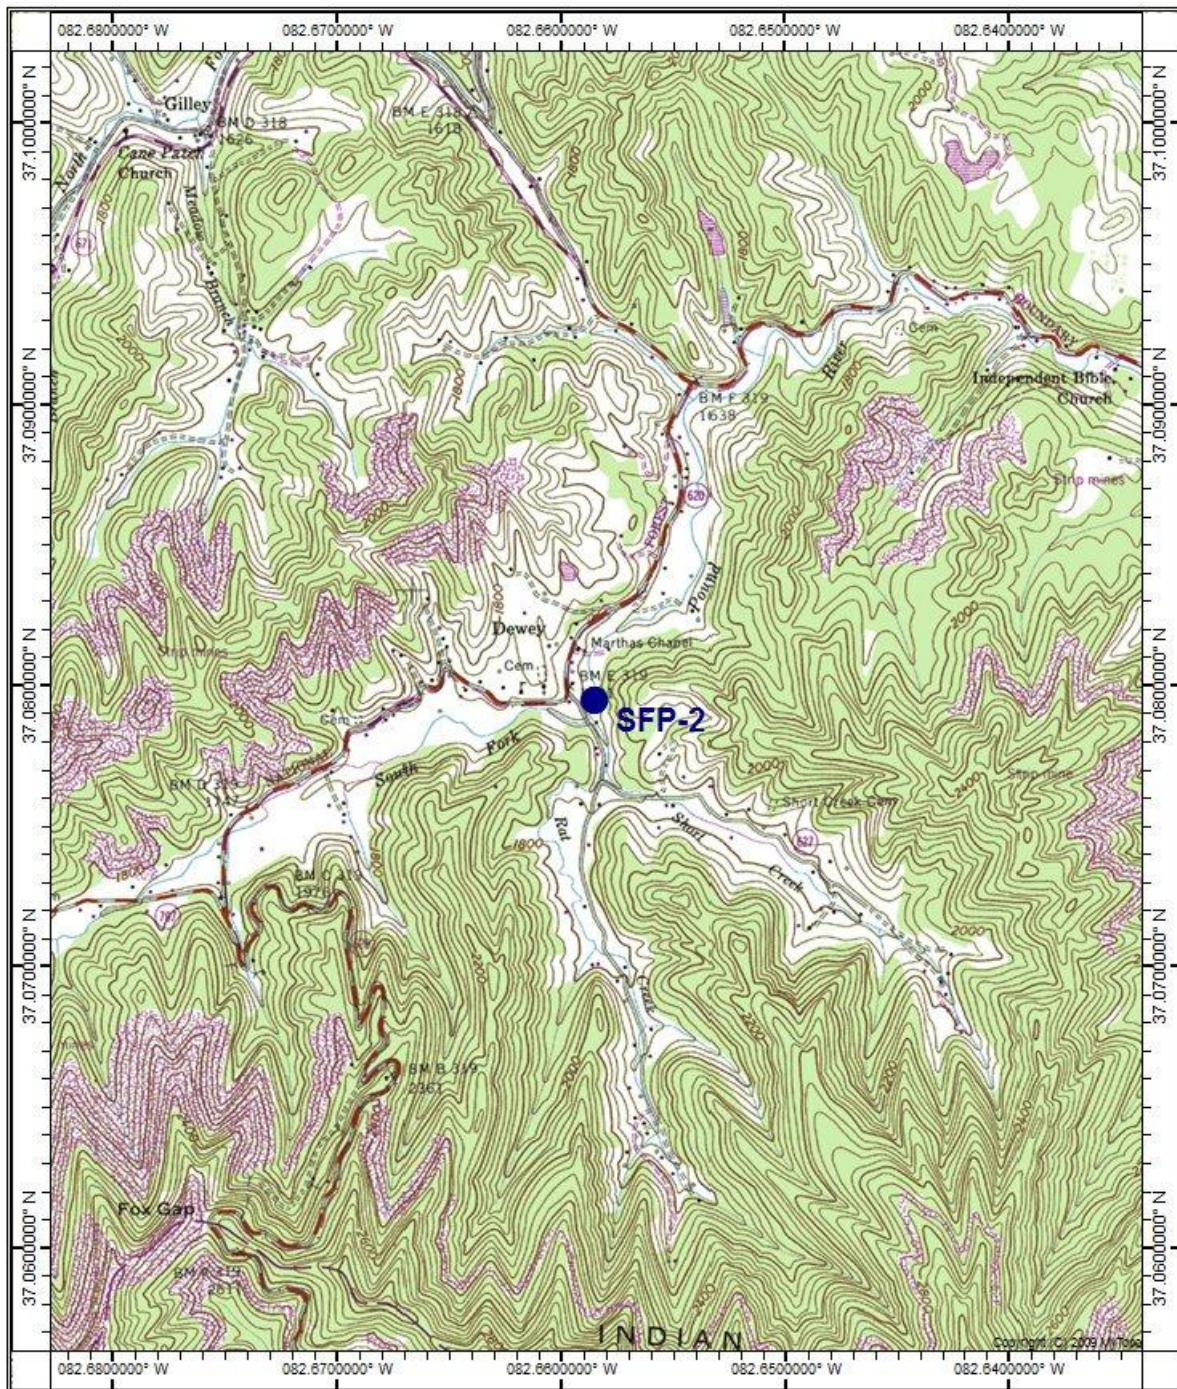
Figure 1. Map of the Monitoring Stations.

One instream monitoring station was specified for this project. Station location was provided by the permittee. These stations were located in Wise County, Virginia and in the South Fork Pound River Watershed. Latitude and longitude coordinates were recorded at the downstream extent of the station using a Garmin<sup>®</sup> Global Positioning System portable unit (GPSMAP 60 CSX). Table 1 summarizes the monitoring station attributes. Figure 1 provides a map of the area and the location of the monitoring stations. Figure 2 presents an orthophoto of study area. Station photographs are presented as Appendix A.

Station attributes, including latitudes and longitudes are presented in Table 1 and depicted in Figures 1 and 2. Station photographs are presented in Appendix A. Flow was adequate for sampling at all stations.

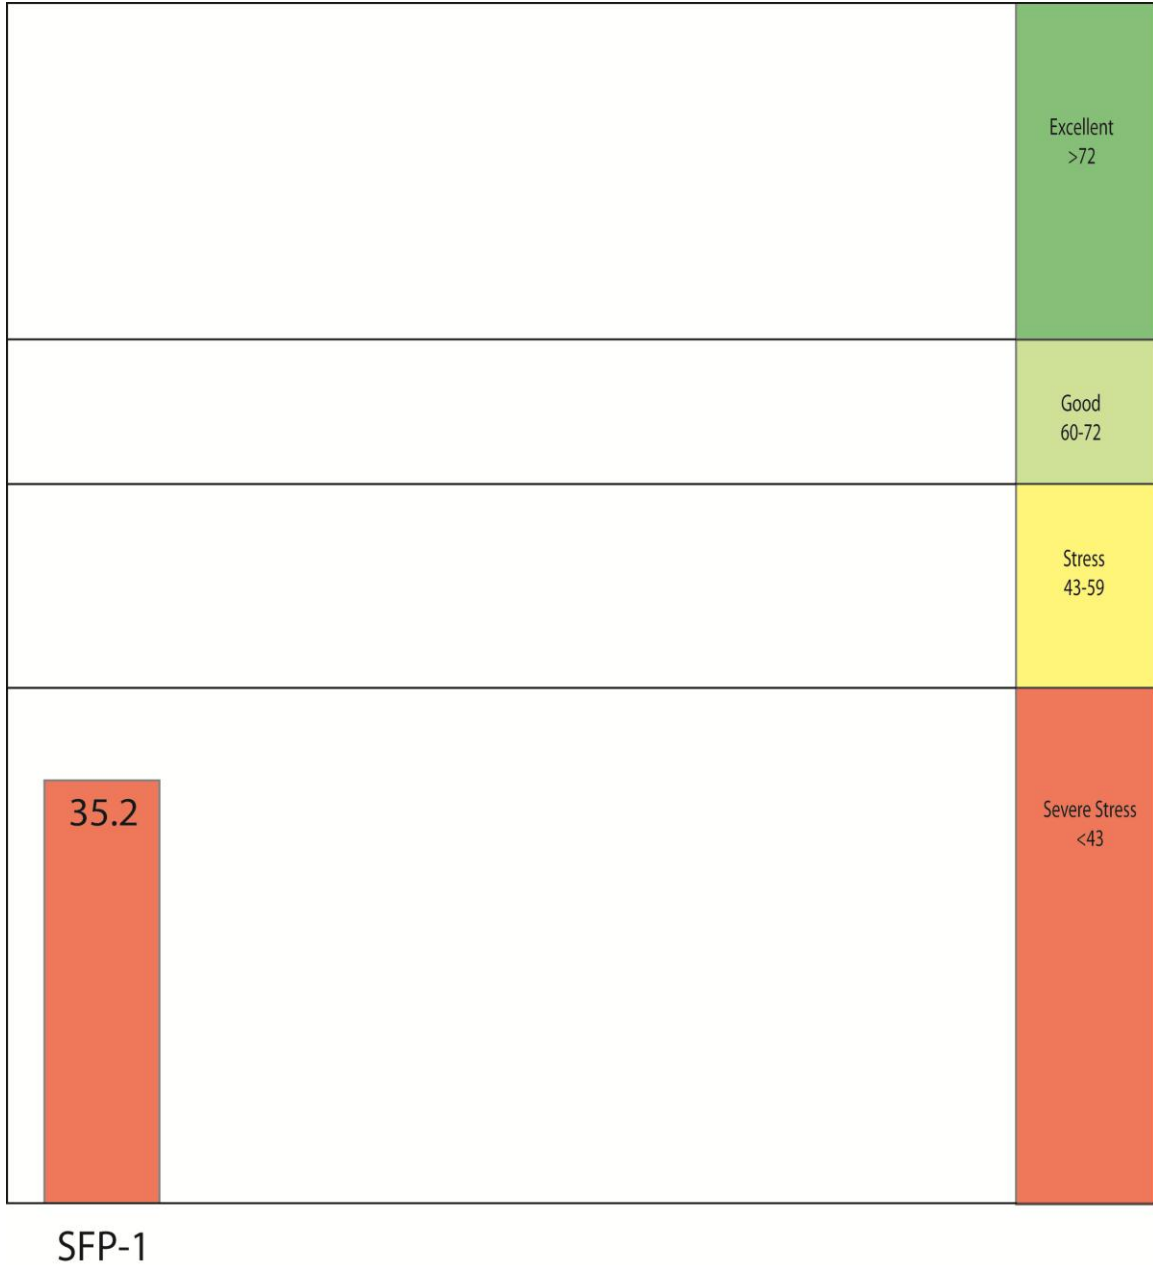
**Figure 3.** VASCI Scoring Summary

Table 6 presents a summary of the VASCI scoring. Raw data are presented in Appendix B. Each metric score represents a percentage of the statewide reference condition. The VASCI score calculated for SFP-2 was 35.15.

Figure 3 is a graphical representation of the VASCI score(s) along with the Aquatic Life Use Tiers. It should be noted that four tiers exist in the VASCI, whereas, a score of 60 or higher is considered “unimpaired” and a score of < 60 is considered “impaired”.

The VASCI score calculated for this permit was 35.15 for station SFP-2. This score falls into the “Severe Stress” Aquatic Life Use tier.
